Scuba Tank Explodes!

From an article in the Norwegian magazine "Diving" written by Kai Garseg [4/97]

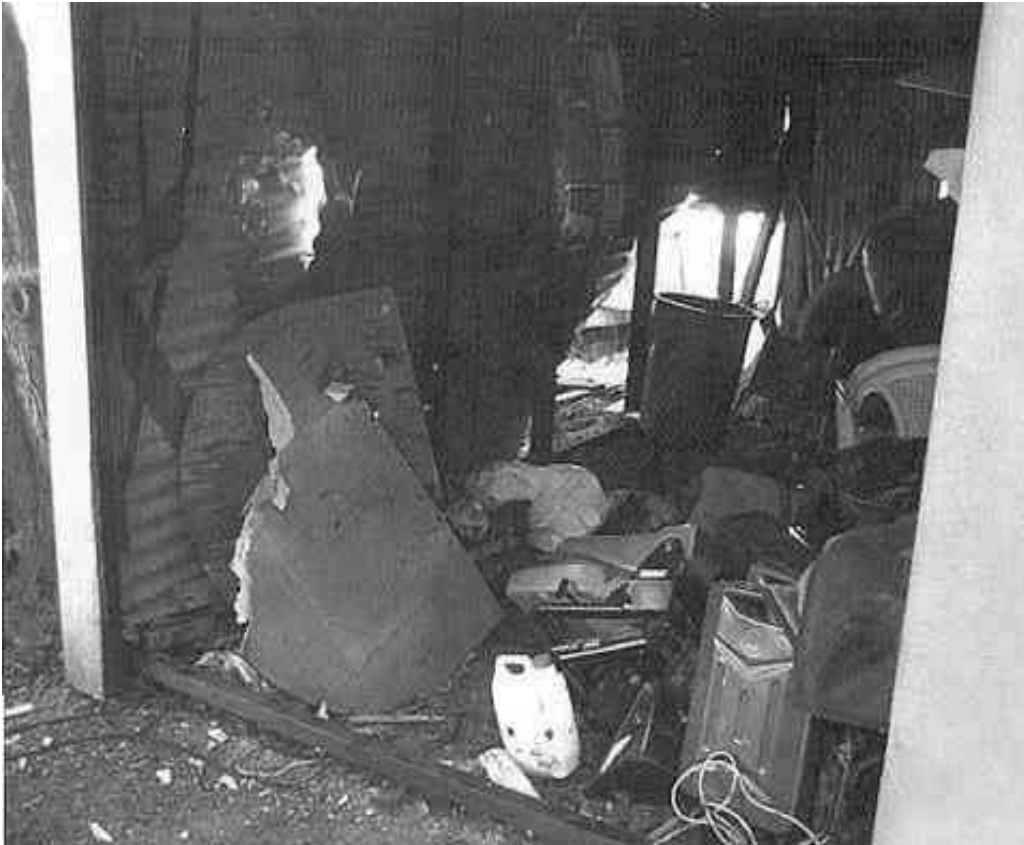
A scuba tank made from aluminum alloy 5283 exploded while sitting inside his garage. The explosion nearly flattened out the garage and everything in it! His 16" winter tires and other things were blown through the walls leaving large holes behind. Fortunately nobody was present.

The back wall of the garage was almost completely gone. Other diving equipment stored along with this bottle was transformed into small bits and pieces. Today, Mr. Deberitz is thankful that nobody was nearby to get injured in the blast.

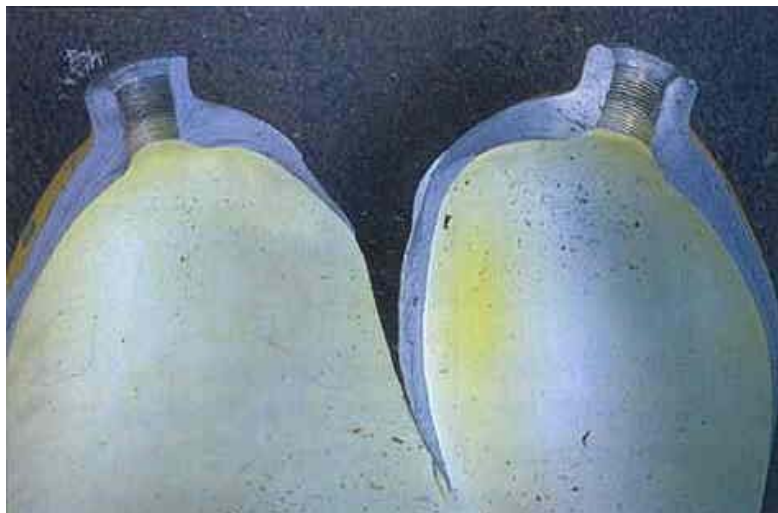
The scuba tank was a 10.3 liter tank which holds about 72 cubic feet of air. It was manufactured by Gerzat (A French Company) in 1973 out of the 5283 aluminum alloy. The 5283 aluminum alloy is just as bad as the 6351 aluminum alloy. The scuba tank itself had been successfully hydrotested in December 1993. The tank had not been used since then and was holding a steady 2800 psi (180 BAR).

The molecular structure of this aluminium alloy seems to change if the tank ever gets overheated, overfilled or over ten years old. If metal valves (other than aluminium) are installed without some kind of plumber's tape, galvanic corrosion will destroy the threads. This phenomenon is hastened whenever the tanks are exposed to water - especially salt water.

He now has proof from the French manufacturer that the explosion was caused by the defective 5283 alloy, and that this scuba tank was a bomb waiting to explode. The local fire department said that the temperature in the garage could not have exceeded 100 F (40 C) on the actual day of explosion.

Although there have been very few scuba tanks that have exploded, there have been similar cases in Sweden, the USA and in some dive shops in the West Indies and other tropical places. While this may be the first such case in Norway, the general opinion in the Norwegian diving industry is to scrap aluminium alloy cylinders of all kinds when they reach 10 years of age.
