SAFETY ALERT

FILLING ALUMINIUM SCUBA CYLINDERS

September 2009

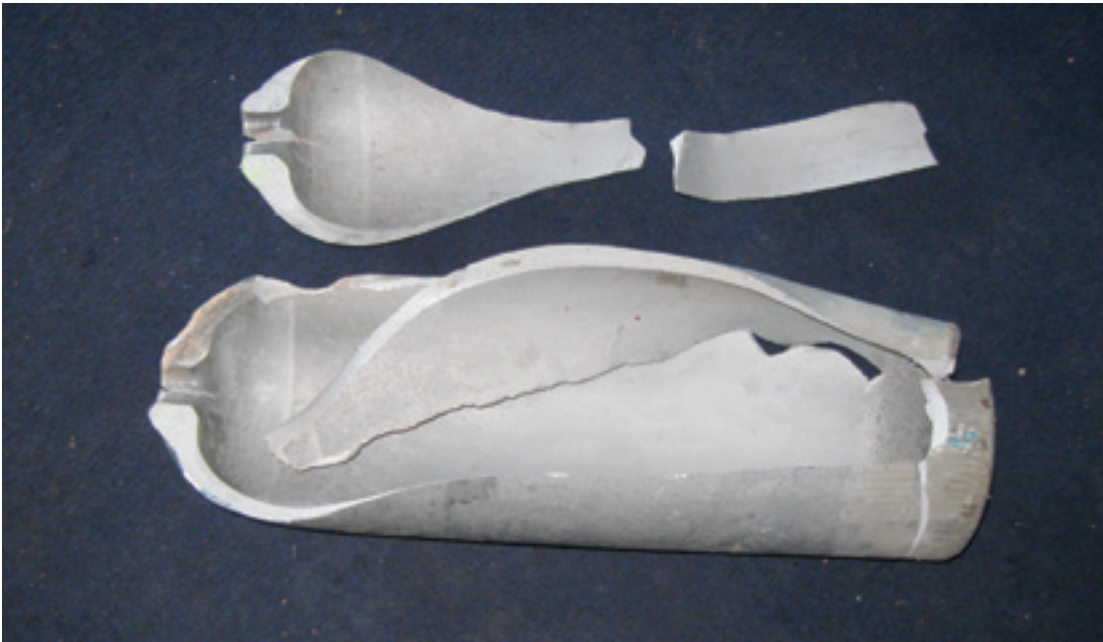
This safety alert is published following serious injuries to a person while filling an aluminium self-contained underwater breathing apparatus (SCUBA) cylinder in August 2009. The cylinder shattered into pieces (see photo).

This is the latest in a number of incidents involving the filling of aluminium SCUBA cylinders manufactured from 6351 alloy. The 6351 alloy was used in:

- aluminium alloy cylinders manufactured between 1972 and 1988 to specifications DOT SP6498, DOT E6498, DOT E7042, DOT E8107, DOT E8364, and DOT E8422
- Australian made aluminium alloy cylinders manufactured before 1991 to AS 1777.

The aluminium SCUBA cylinders listed above should only be refilled in a manner that minimises the risk to people and property in the event of a failure – eg they should only be filled in a suitable enclosure.

The following control measures apply when filling cylinders, including aluminium SCUBA cylinders:

- inspect a cylinder before filling it
- do not fill, or use, a damaged cylinder – eg if there is evidence of surface gouging, cuts, dents or damaged fittings

- do not fill a cylinder that is without a valid test date stamped on it – SCUBA cylinder tests are only valid for 12 months
- do not fill a cylinder to a pressure that is greater than the working pressure stamped on it

- fill a cylinder slowly to prevent an excessive rise in temperature, or if filling it faster, remove the excessive heat during filling, by refrigerating the gas or immersing the cylinder in cold water

- do not tamper with the valve unit safety valve fitting or rupture disc
- do not approach the cylinder if you detect a leak – don't assume the leaking sound is due to a leaking connection of the filling apparatus. Evacuate the area and allow the cylinder to discharge, or discharge the cylinder once you consider it safe to do so. Only investigate the cause of the leak when the cylinder has discharged.

- flexible connections (eg hoses) should be suitably restrained before filling, otherwise they may whip if the hose bursts or disconnect when pressurised.
