Scuba Tank Explodes!

From an article in the Norwegian magazine "Diving" written by Kai Garseg [4/97]

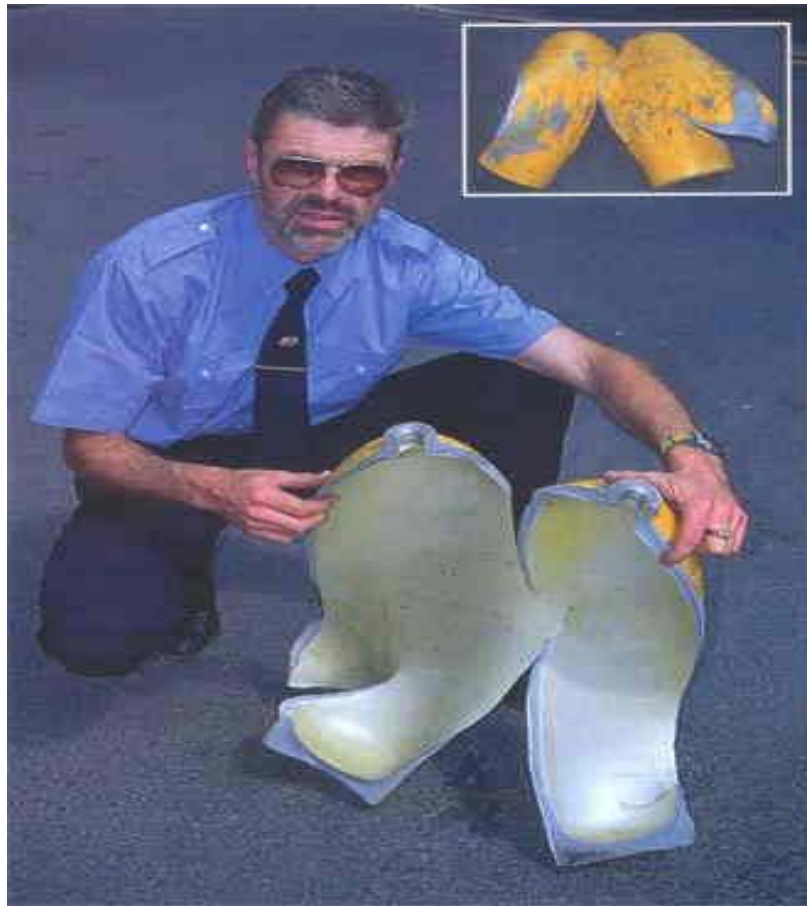
A scuba tank made from aluminum alloy 5283 exploded while sitting inside his garage. The explosion nearly flattened out the garage and everything in it! His 16" winter tires and other things were blown through the walls leaving large holes behind. Fortunately nobody was present.

The back wall of the garage was almost completely gone. Other diving equipment stored along with this bottle was transformed into small bits and pieces. Today, Mr. Deberitz is thankful that nobody was nearby to get injured in the blast.

The scuba tank was a 10.3 liter tank which holds about 72 cubic feet of air. It was manufactured by Gerzat (A French Company) in 1973 out of the 5283 aluminum alloy. The 5283 aluminum alloy is just as bad as the 6351 aluminum alloy. The scuba tank itself had been successfully hydrotested in December 1993. The tank had not been used since then and was holding a steady 2800 psi (180 BAR).

He now has proof from the French manufacturer that the explosion was caused by the defective 5283 alloy, and that this scuba tank was a bomb waiting to explode. The local fire department said that the temperature in the garage could not have exceeded 100 F (40 C) on the actual day of explosion.

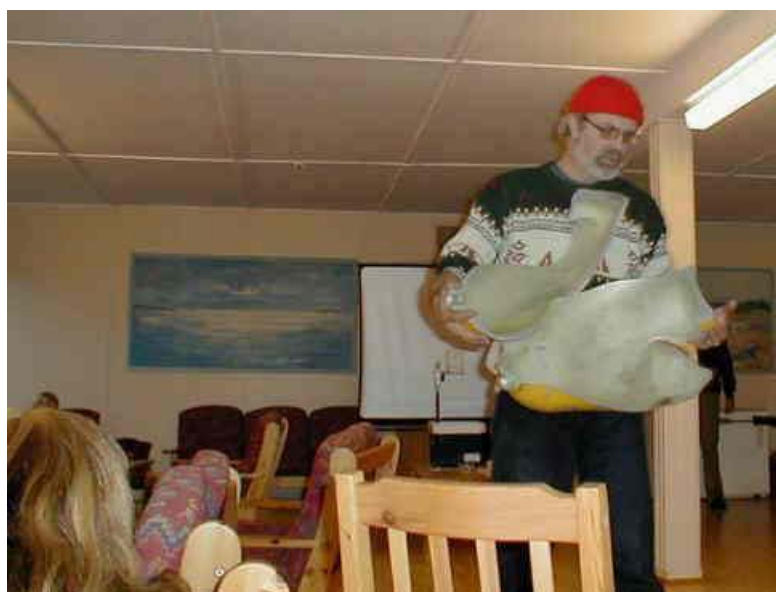
The following photograph was taken on Saturday, 9/9/2001 at "Tjömetreffen2001", a dive camp held by Dag's diving club. Arild Vangen from Poseidon Service in Oslo held an information meeting and showed equipment telling about proper handling, storage, maintenance and use of diving equipment and high pressure compressors. There were 39 divers who attended from Germany, Holland, Norway and Scandinavia. Of these 39 divers, 8 had scuba tanks made from 6351, Gerzat 5283 or similar alloys!
